Sound Study 1 - November 2, 2015

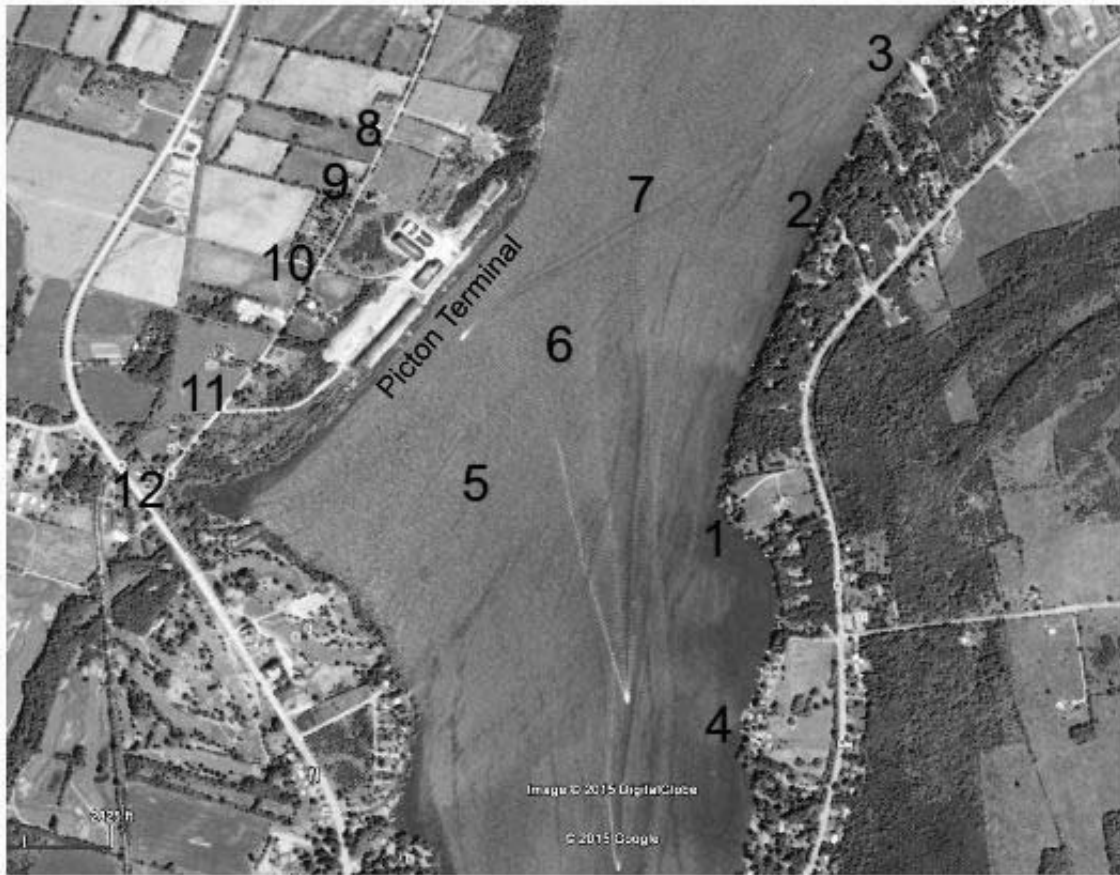
Sound Study Location Points

Situation	No operations on site	Dock access road building & rock removal Excavating crew, 4 trucks & excavator	Unloading Federal Kivalina LH120 and trucks operating	Regular site operations Screener running, crusher running
Weather	<i>16 degrees celcius 10 Km/h wind and clear skies</i>	<i>20 degress celius less than 10 Km/h and cloudy skies</i>	<i>22 degrees celius less than 5 Km/h wind and clear skies</i>	<i>9 degrees celius less than 10 Km/h wind and clear skies</i>
Date:	<i>15 July 2015</i>	<i>22 July 2015</i>	<i>7Aug 2015</i>	<i>26 Oct 2015</i>
Time of day	<i>6:00 AM</i>	<i>10:00 AM</i>	<i>2:00 PM</i>	<i>3:00 PM</i>
1	<i>67.9</i>	<i>73</i>	<i>65.5</i>	<i>62.8</i>
2	<i>65.3</i>	<i>91*</i>	<i>64.4</i>	<i>66.9</i>
3	<i>65.5</i>	<i>82</i>	<i>65.6</i>	<i>66.7</i>
4	<i>67.5</i>	<i>76.3</i>	<i>59.6</i>	<i>69.7</i>
5	<i>62.3</i>	<i>76.1</i>	<i>76.1</i>	<i>69.9</i>
6	<i>62.7</i>	<i>77.6</i>	<i>75.4</i>	<i>68.3</i>

7	<i>63.6</i>	<i>78.7</i>	<i>71.6</i>	<i>68.9</i>
8	<i>57.7</i>	<i>-</i>	<i>60.8</i>	<i>61.4</i>
9	<i>-</i>	<i>60</i>	<i>59.4</i>	<i>62.7</i>
10	<i>-</i>	<i>61.4</i>	<i>61.1</i>	<i>61.6</i>
11	<i>-</i>	<i>61.4</i>	<i>58.6</i>	<i>59.4</i>
12	<i>59.2</i>	<i>55.3</i>	<i>65.5</i>	<i>64.1</i>
